FIELD COLUMBIAN MUSEUM

PUBLICATION 28.

RUINS OF XKICHMOOK, YUCATAN

EDWARD H. THOMPSON,

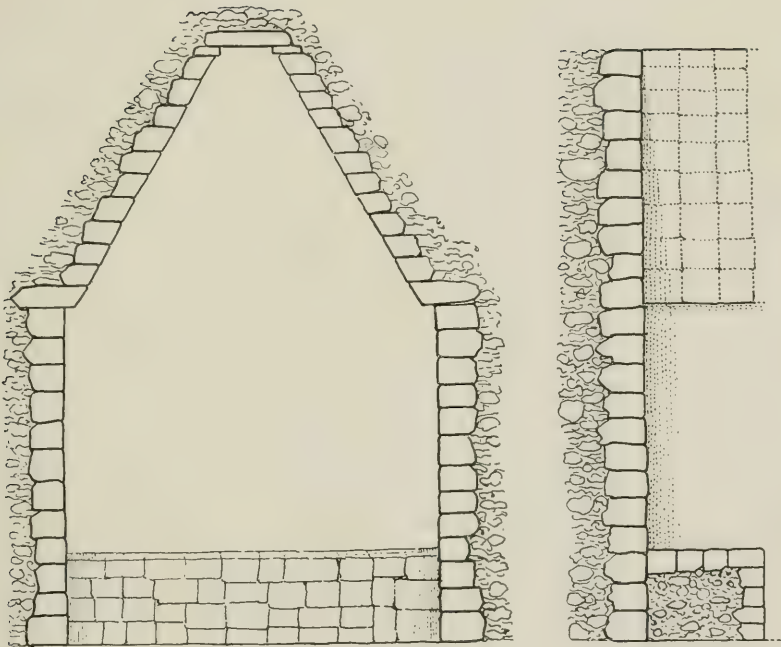
FIG. 23. SECTION OF CHAMBER, WITH FRONT VIEW OF STONE PLATFORM.

FIG. 24. SECTION OF END OF CHAMBER, WITH SECTION OF STONE PLATFORM.

Five of the Palace chambers have platforms at one or both ends of the rooms, raised about 18 inches above the floor and about 2 feet wide. (See Figs. 23 and 24.) Their shape and size would indicate that they had served for seats, beds or tables.

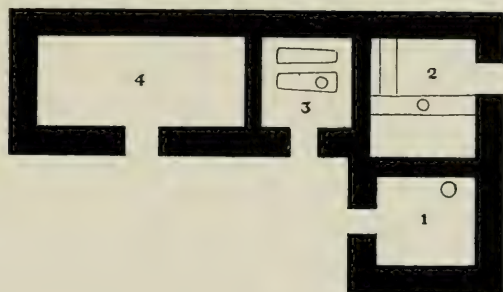
FIG. 25. PLAN OF EDIFICE No. 8.

EXCAVATIONS (EDIFICE No. 8).—Edifice No. 8 (Fig. 25) appeared at first glance to be simply an ordinary mound, so utterly was it ruined.

The roof-stones found here and there told the story of its original character, and excavation was continued until the bed-rock itself stopped the work. At the distance of a foot beneath the surface of the floor we found traces of an older floor. Buried a foot deep in the material of the floor was a rude grave and a shallow earthen dish inverted over a heap of human bones. Near by were fragments of clay figurines and potsherds. Beneath these objects was a third floor, and a few inches deeper still another. This is the first time I have found so many floors. A foot deeper we struck a filling of great stones that continued down to the bed-rock and yielded nothing of note.

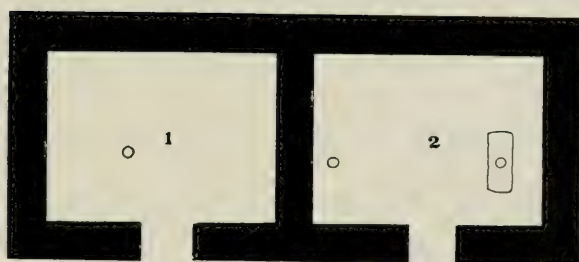
FIG. 26. PLAN OF EDIFICE No. 9.

EXCAVATIONS (EDIFICE NO. 9).—This edifice (Fig. 26) also appeared at first to be a large, shapeless mound, but excavation revealed a structure of two chambers, and in Chamber No. 1, at a depth of 9 inches beneath the floor, one small earthen jar and the fragments of several other vessels were found. Excavation in Chamber No. 2, at a depth of 2 feet 8 inches beneath the floor and 2 feet from the west

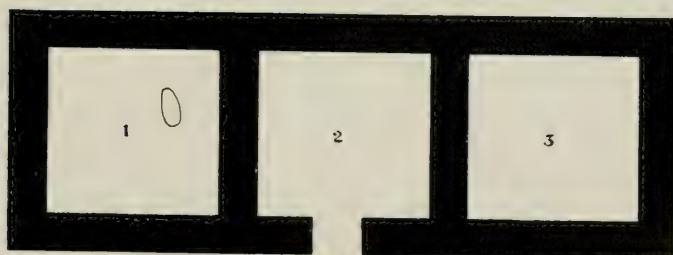
FIG. 27. PLAN OF EDIFICE No. 10.

EXCAVATIONS (EDIFICE NO. 10).—Edifice No: 10 (Fig. 27) was a mere mound, concealing within its mass, however, a ruined three-chambered structure. Excavation in Chamber No. 1 yielded many potsherds, and in the southeast corner was a rudely formed cavity holding a heap of badly decayed bones and human teeth. Chamber No. 2 contained an accumulation of potsherds, while Chamber No. 3 held potsherds and two cylindrical rubbing stones, the surfaces of the latter being highly polished by attrition.

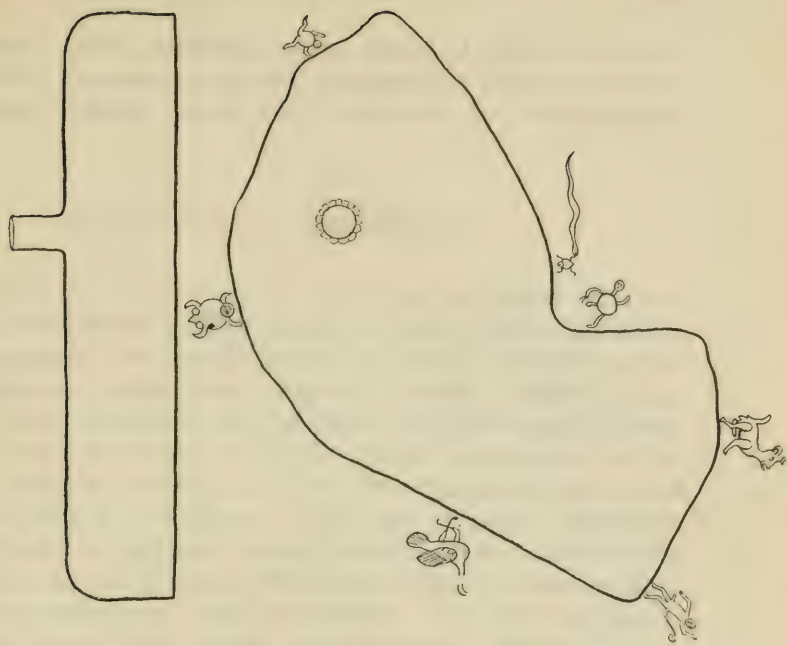
FIG. 31. SECTION OF RESERVOIR, 3 LEAGUES NORTHEAST OF XKICHMOOK.

Three leagues northeast of Xkichmook lies the Indian ranche of Nucuchtuk, built on the site of a small group of ruins. Within the group I encountered and excavated a most singular chultune. It was extremely shallow and, unlike the previously described examples, was quite close to the surface and very wide. Its walls have a most curious assortment of figures worked in stucco. Close by the orifice upon either side were two nondescript figures, and distributed around the walls were an ape, a wild turkey, a deer-like animal, a serpent and a frog. These are shown imperfectly in connection with the section of the reservoir in Fig. 31. I have personally explored the depths of more than a hundred chultunes, but this exceeds in interest any other I have found.

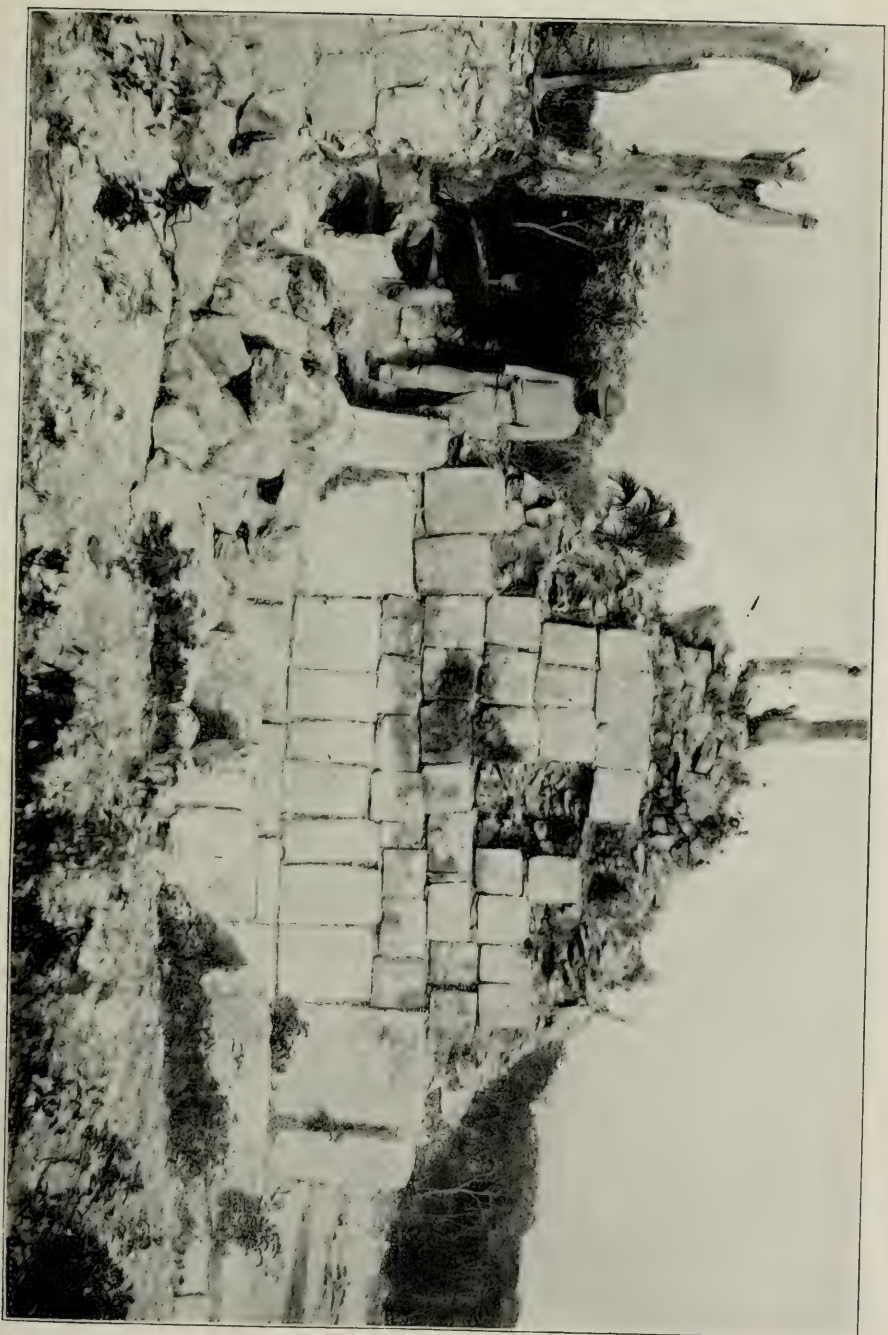
EDIFICE NO. 2, SHOWING MASONRY.

EXCAVATIONS.—Superficial excavation revealed the outlines of the edifice as shown upon the map, and the character of the masonry is well brought out in Pl. XV. Excavations beneath the floor surface of Chamber No. 1, at a depth of 1 foot and 8 inches, brought to light a rude sepulchre which was hardly more than a simple cavity in the stone filling. This cavity contained the much decayed fragments of a human skeleton. They had, apparently, been gathered up from some previous resting place and thrown into this cavity in a promiscuous heap. No signs of an earthen vessel or even of an ornament were found in the grave. Continuing the excavation into the material of the substructure, we found at a depth of 2 feet the remains of a second floor of an older structure. Apparently, this latter had been built partly above and upon the site of a still older edifice. This I have often found to be the case among these ruins. In the debris material I found many fragments of objects in terra cotta. Similar excavations in the floor material of Chamber No. 2 revealed, at a distance of 3 feet from the northern wall, a well-made grave 3 feet long by 1 foot 4 inches wide and 2 feet deep, which contained many human bones and teeth, all much decayed. In the material just above the grave I found many terra cotta fragments of vessels and figures. These votive offerings were evidently broken and thrown upon the half-covered grave. As in the excavations of Chamber No. 1, we found here signs of a previous floor. Continuing to the depth of 3 feet more we came to the bed-rock and consequently to the limit of our excavation at that point. All the way from the surface down we found potsherds in great variety.

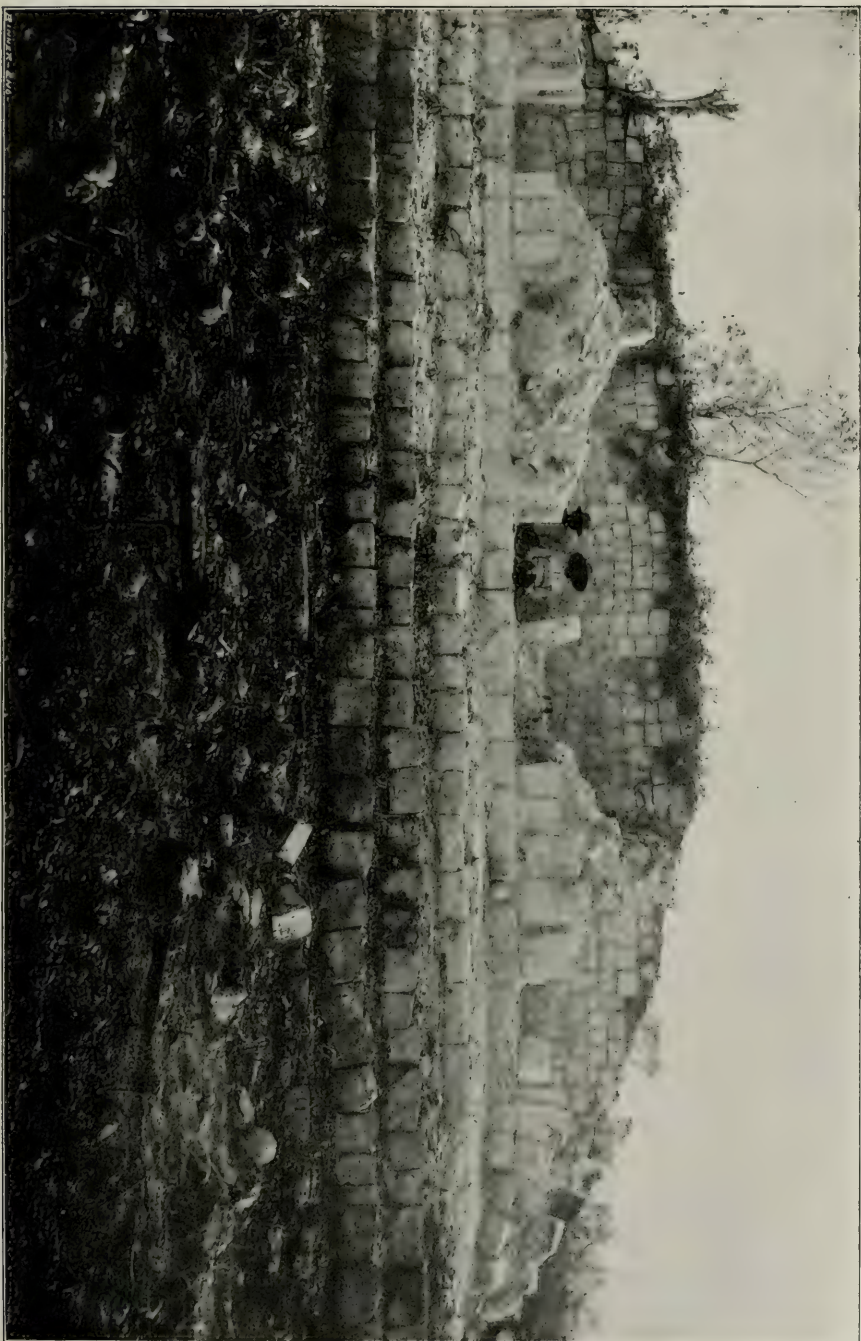
EDIFICE NO. 3, AS EXPOSED BY EXCAVATION, SHOWING STAIRWAY AND HALLS.

Southeast of Edifice No. 2 is Edifice No. 3, a low structure of five rooms. It occupies a terrace 6 feet high, and is approached both on the north and south by flights of stairs extending the entire length of the structure. This building, with its series of steps faced with upright stones as they appeared after excavation was complete, is well shown in Pl. XVI.

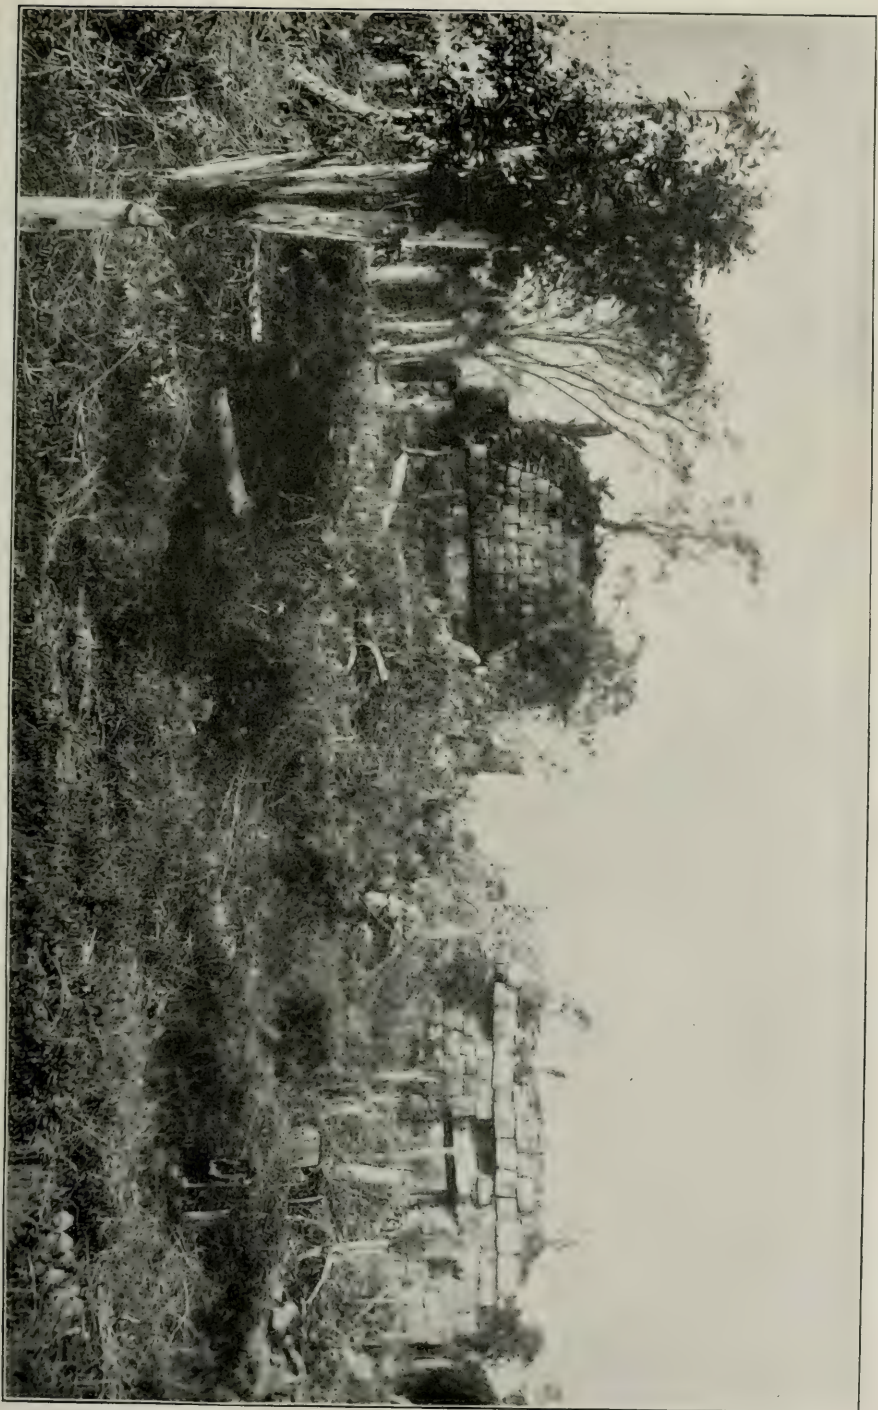
EDIFICE NO. 4, AS IT APPEARED AFTER REMOVAL OF THE FOREST GROWTH.

Edifice No. 4 is on the east side of the structure above described, and is separated from it by a narrow space only 5 feet wide. The chambers of this structure, nine in number, one being still intact, surround a solid, rectangular core of stone and rubble. This ruin, as it appeared when the forest trees and undergrowth were removed, is seen in Pl. XVII.

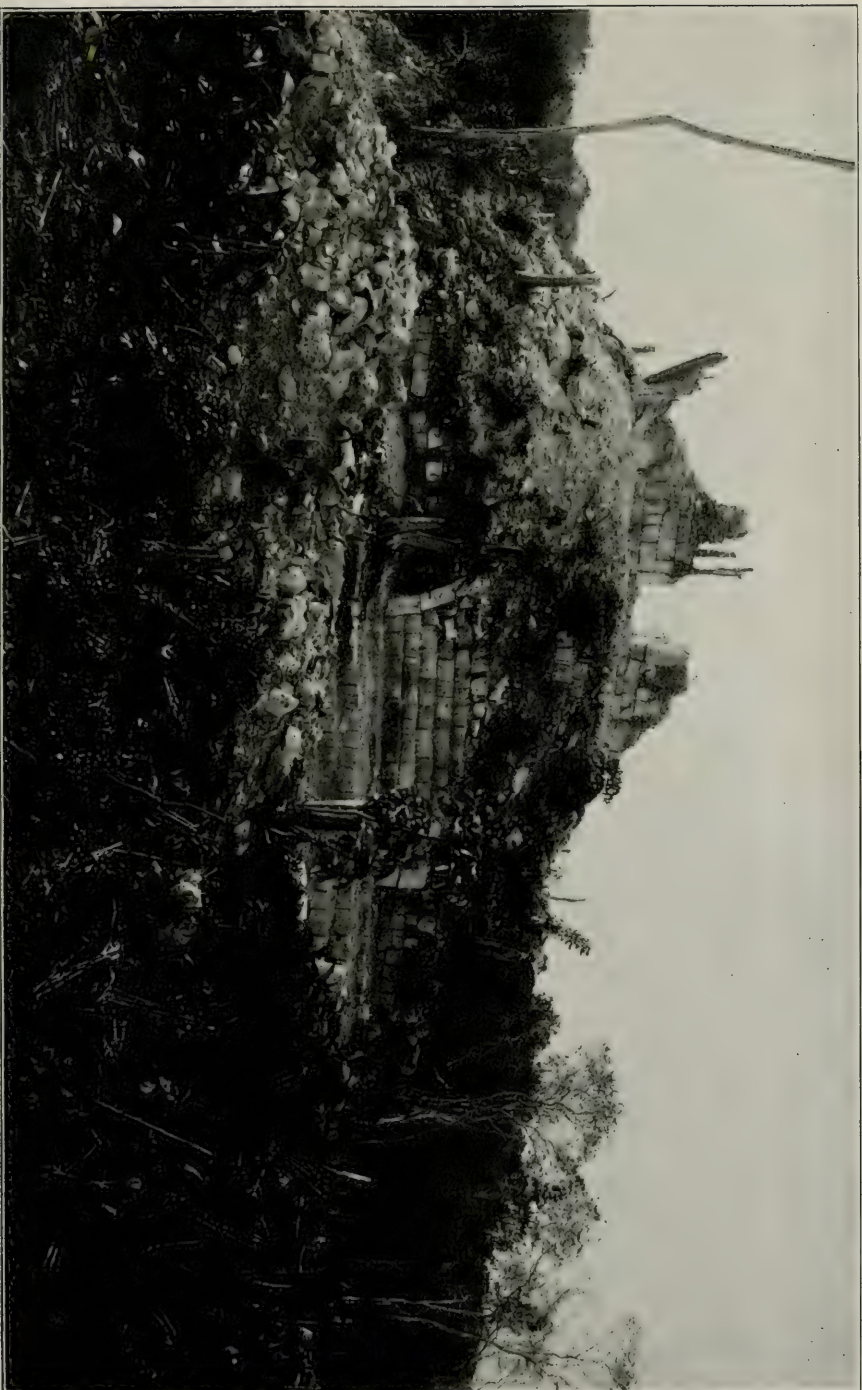
EDIFICE NO. 7, AFTER EXCAVATION, SHOWING STAIRWAY AND REMNANT OF FACADE.

When first examined all that could be noted of this ruin was a platform having upon its eastern edge a high, featureless mound. Excavation gradually developed the outline of a walled structure, one-storied and single-chambered, raised on a terrace 30 feet high and facing an enclosed courtyard. It communicated by stone stairways of various dimensions with the terrace facing it. (See Pl. XX.)

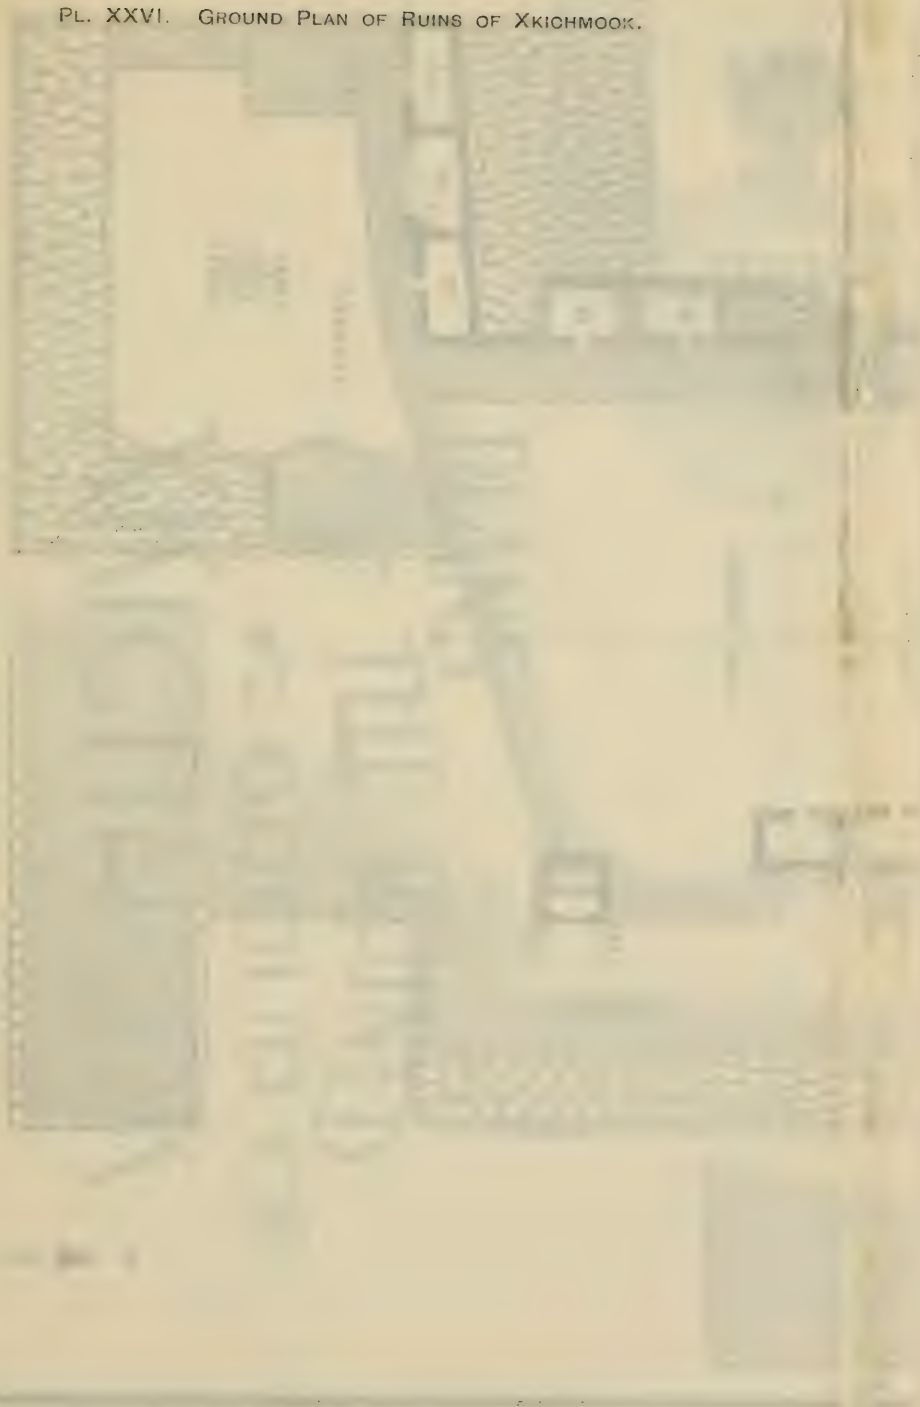
PL. XXVI. GROUND PLAN OF RUINS OF XKICHMOOK.

PLANS OF THE RUINED OF *D GROUP OF XICHMOOK

This edifice is on the main terrace, about 90 feet eastward of the Palace, and is intimately connected with that structure, as shown in the plan, Pl. XXVI.

Mound No. 1 (see ground plan, Pl. XXVI) showed no evidence of having supported a superstructure. There were three graves in a very ruined state, which contained several earthen vessels, nearly or quite complete, as well as many potsherds. Excavation of Mound No. 3 revealed two graves even more completely ruined than those found in Mound No. 1. They held several vessels of the usual pattern—one being a shallow dish with base serrated on the edge—fragments of human bones much decayed, and some stone beads.

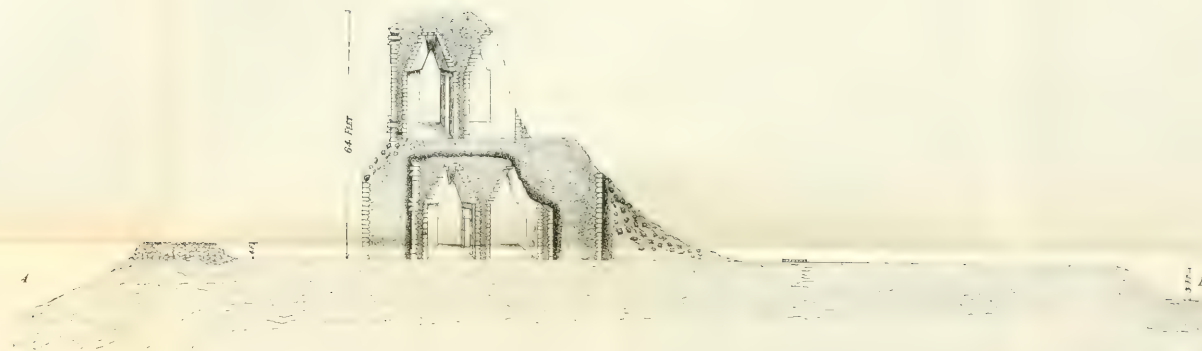
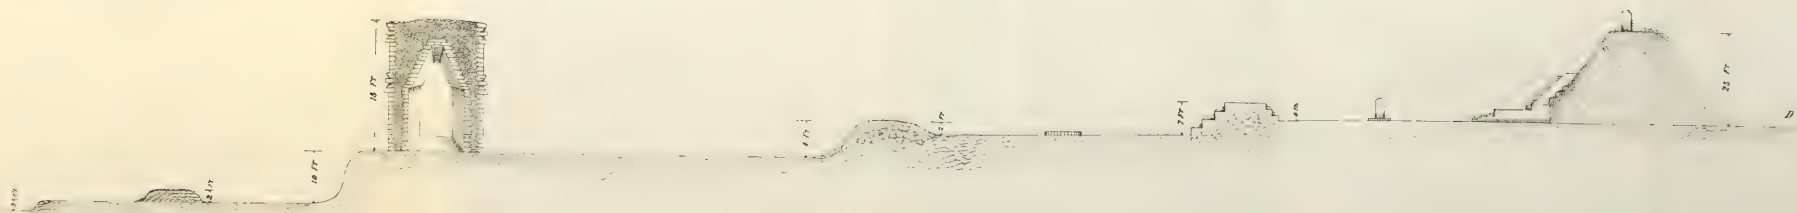
FIVE TRANSVERSE SECTIONS SHOWING ELEVATIONS OF GROUND PLAN (PL. XXVI)
